PUBLIC ROADS

November 1939

STUDIES OF WATER-RETENTIVE CHEMICALS AS ADMIXTURES WITH NONPLASTIC ROAD-BUILDING MATERIALS

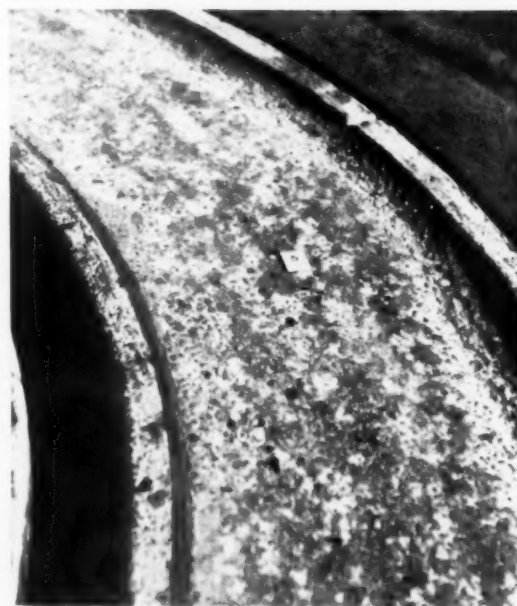
Raveling of the surface under distributed traffic was first noted at about 160,000 wheel-trips in section 5 and progressed gradually to 184,000 wheel-trips, when sprinkling was started. At this time sections 2, 3, and 4 had also started to ravel to some extent along the curb line. The condition of section 5 is illustrated in figure 7.

FIGURE 7.—SECTION 5 OF TRACK 2 AT 184,000 WHEEL-TRIPS, JUST BEFORE THE FIRST SPRINKLING. SOME RAVELING HAD DEVELOPED, PARTICULARLY ALONG THE EDGES.

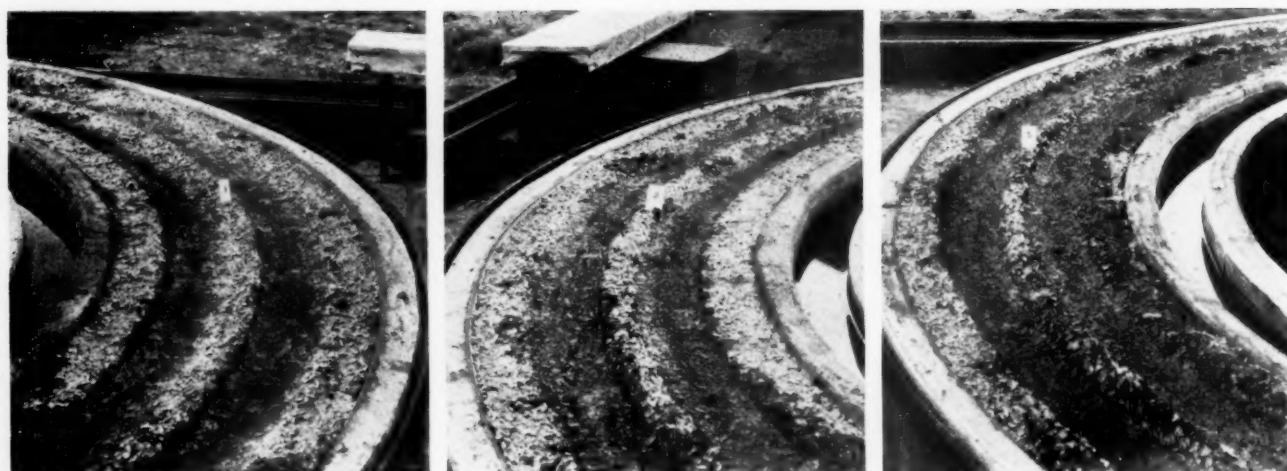
FIGURE 9.—SECTIONS OF TRACK 2 AT THE CONCLUSION OF THE TEST. LEFT, SECTION 1; MIDDLE, SECTION 3, WHICH IS ALSO REPRESENTATIVE OF SECTIONS 2 AND 4; RIGHT, SECTION 5.

When the test was concluded at 407,000 wheel-trips, section 1 was in fairly good condition except for the superficial rutting caused by poor compaction of the surface treatment (fig. 9), and showed the least amount of displacement. Profilometer measurements indicated the greatest amounts of movement to have occurred in sections 2 and 4. The appearance of these two sections at the end of test was very similar to that of section 3, shown in figure 9. The surface treatment on all three of these sections had cracked between the wheel courses. Section 5 was showing signs of failure at the end of the test although the total vertical displacement was not as great as for some of the other sections. The surface treatment was breaking and the section was becoming rough generally as shown in figure 9.
